# Manhole Inspection Summary

Manhole # S33C\_\_012MH

Insp Date: **8/12/09 12:31 PM**

**Location** Address: **200 Saratoga St**

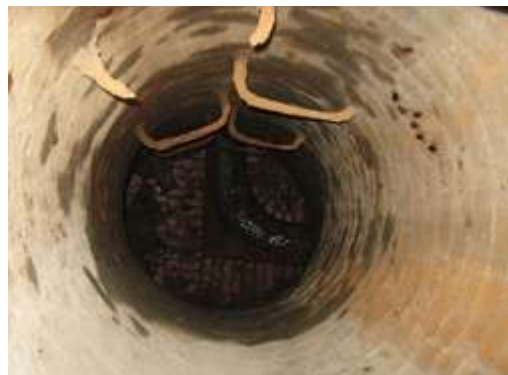
Defect 1

Infiltration: ☐ None ☐ Joint ☐ Cracks ☐ Mortar ☐ Roots ☒ **Wall**

**Steps** Count: **8** Missing: **2** ☒ **Corroded**

missing/corroded steps; infiltration in chimney wall

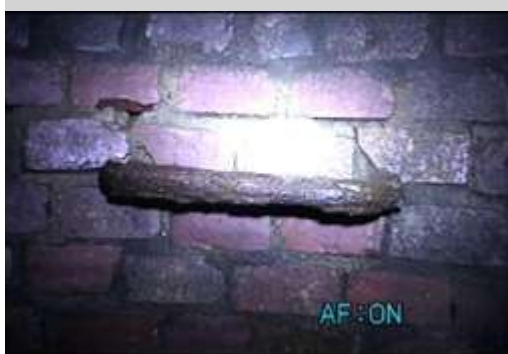
Defect 4

Condition: ☐ Sound ☒ **Cracked** ☐ Root Intrusion ☐ Loose Brick ☐ Deteriorated

cracked/broken brick in barrel

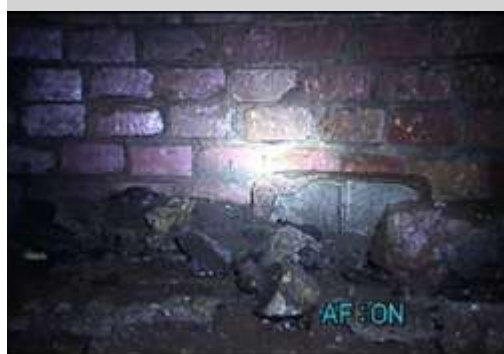
Defect 3

Condition: ☐ Sound ☐ Cracked ☐ Root Intrusion ☐ Deteriorated ☐ Leaks ☒ **Debris**

Debris on bench

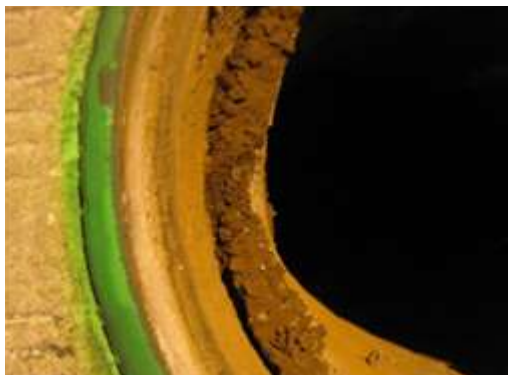
Defect 2

**Frame** Offset: **3** (in.) Condition: ☒ Sound ☐ Cracked ☐ Leaks

offset frame
